# Boston's Open Space

1987  
PARK EVALUATION  
&  
SITE SUMMARIES

EVALUATION OF  
CITY OF BOSTON  
PARK AND RECREATION LAND

NEIGHBORHOOD OF ALLSTON/BRIGHTON

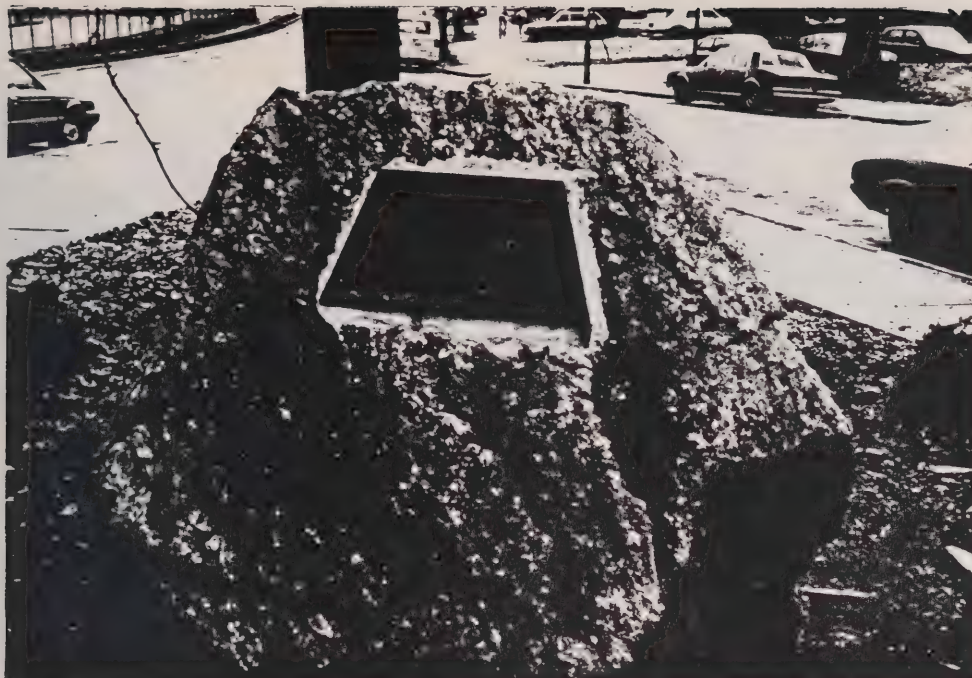
### Site Photograph 1

Monument. Bed behind is planted with groundcover that has not done well.

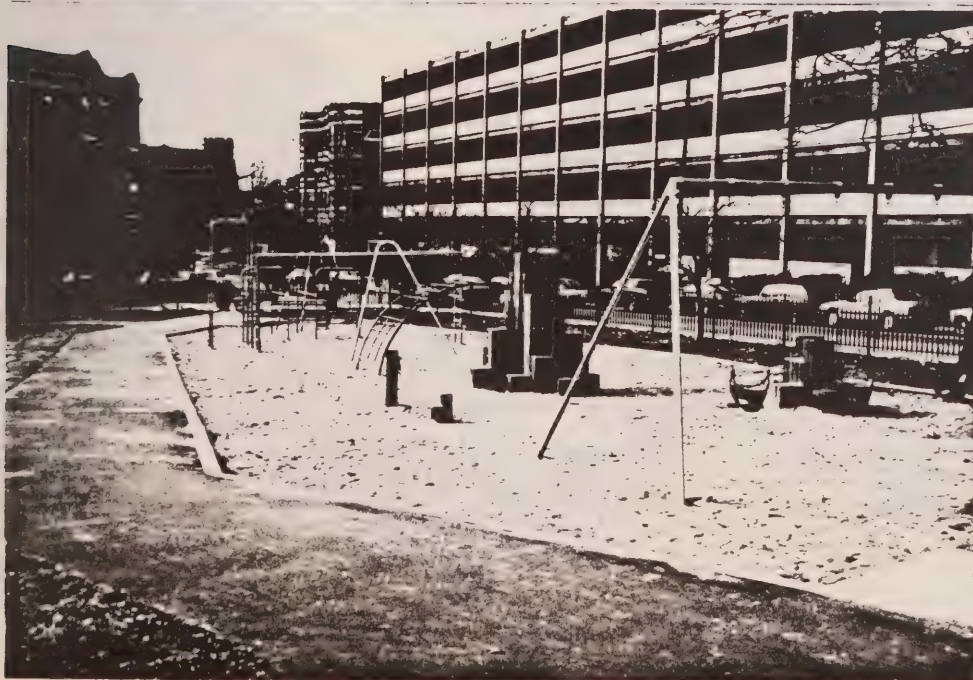
### Site Photograph 3

New playground in good condition. Typical neighborhood behind.

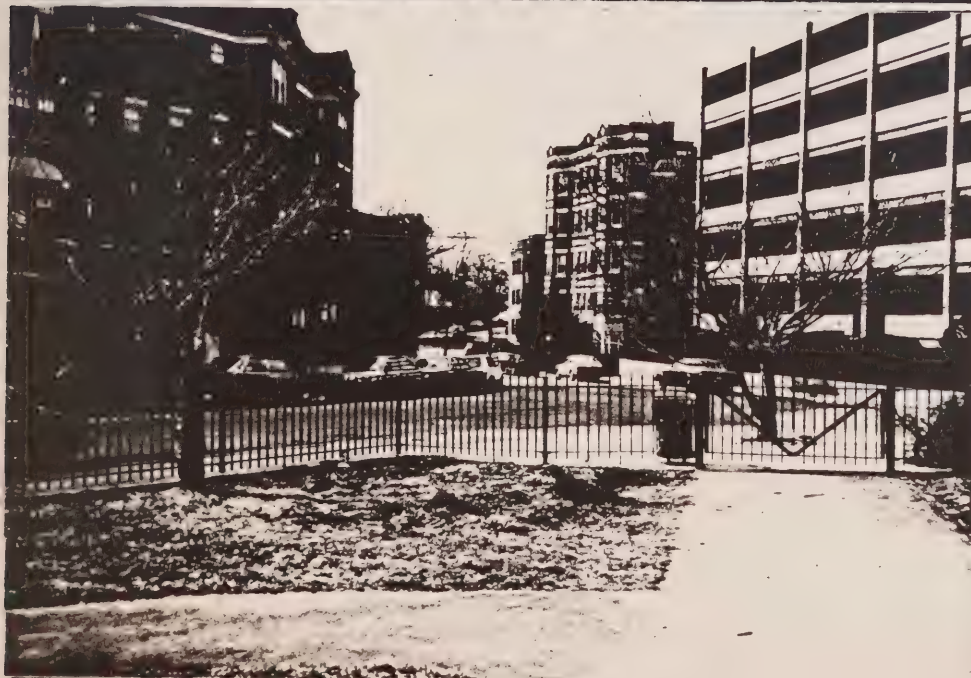
**Site Photograph 6**

An entrance showing  
area to be replanted  
where Junipers have  
died.

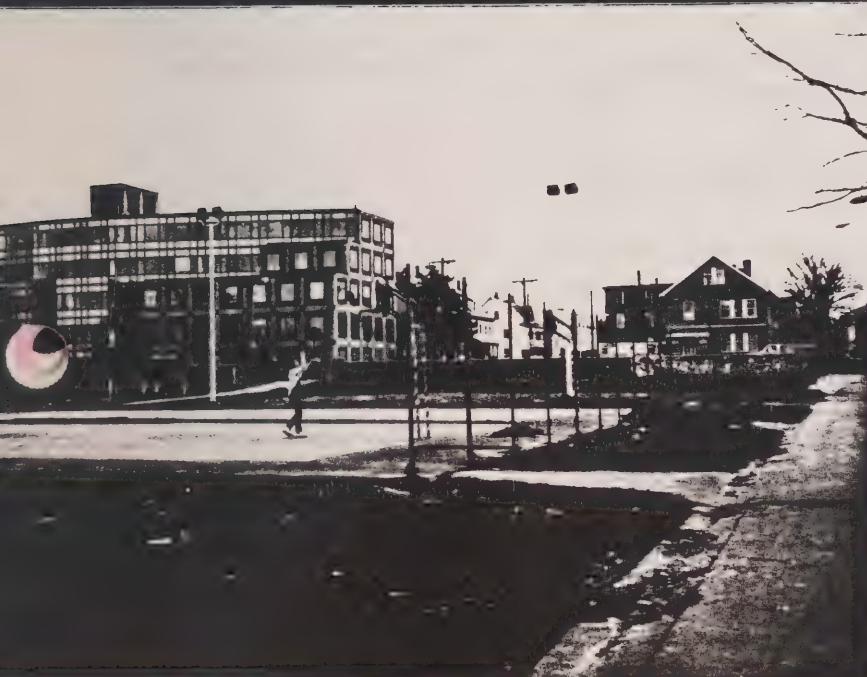
### Site Photograph 2

Existing basketball courts. New fence being constructed.

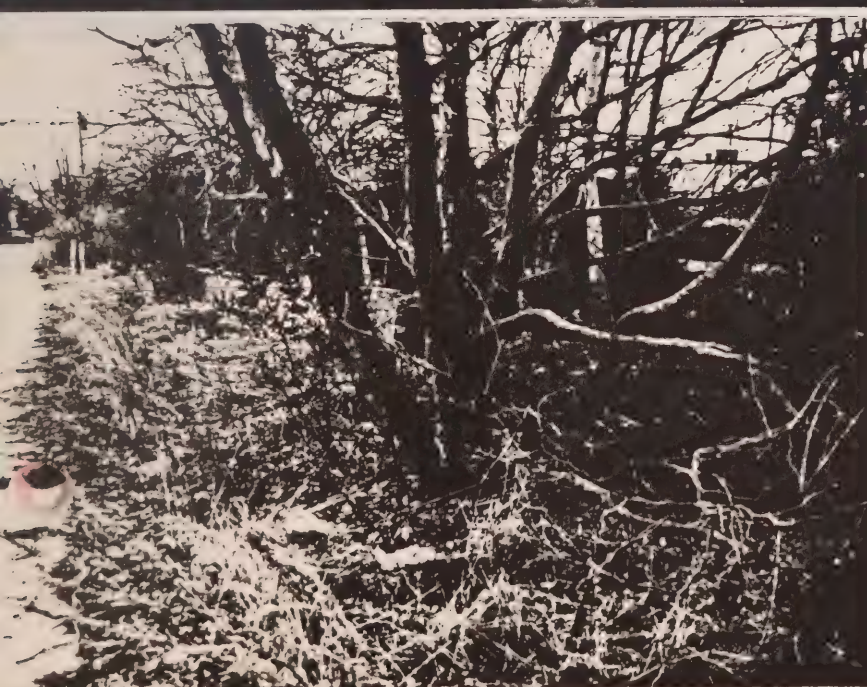
### Site Photograph 3

Coppiced Sycamore and stone wall along property line. Maintenance poor along this edge.

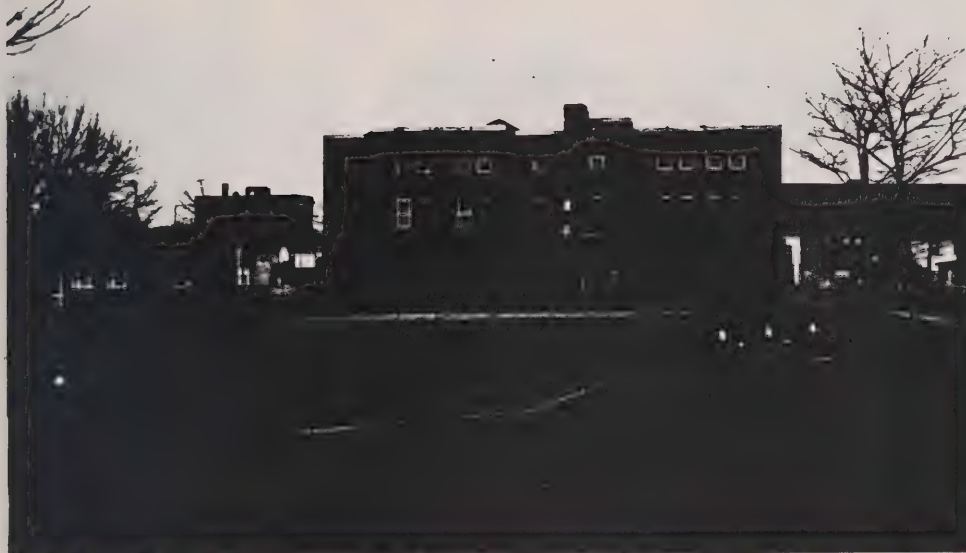
### Site Photograph 1

View through site showing vacant school beyond and cross-pitch of sitting area.

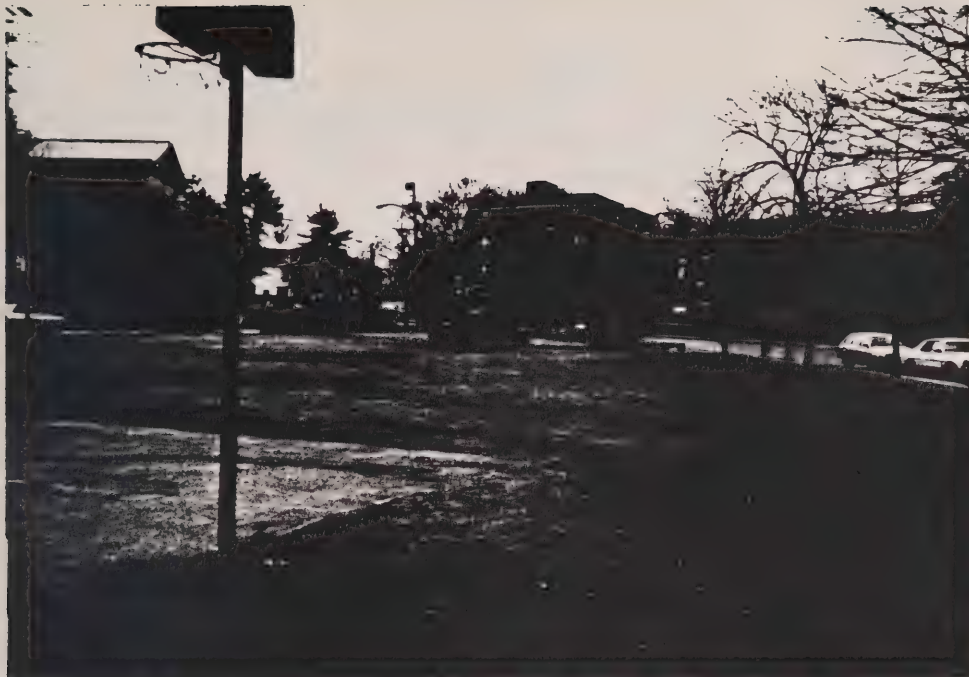
**Site Photograph 4**

View through site  
towards timber planters.

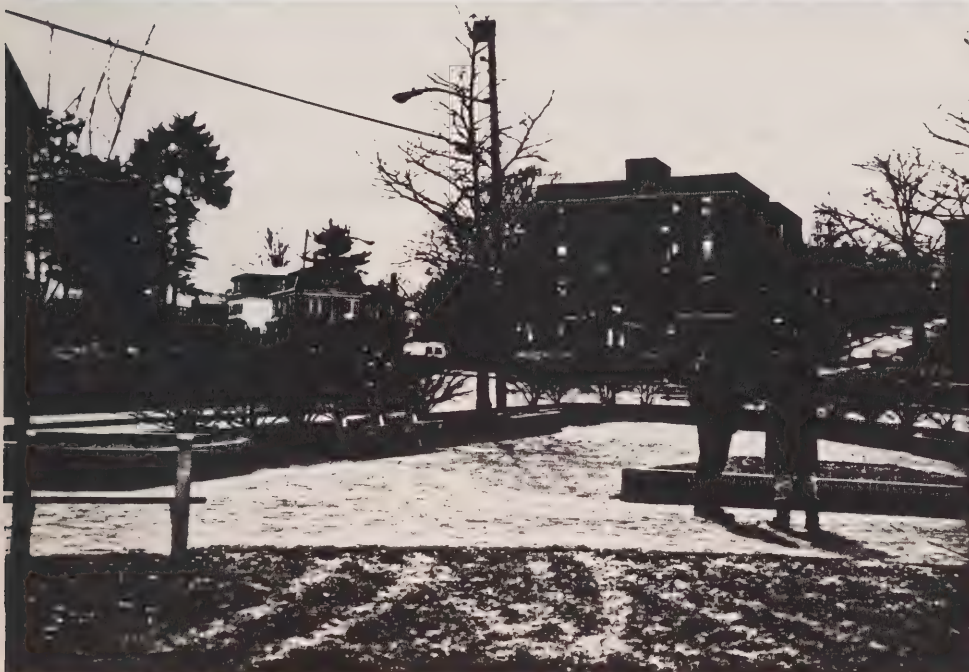
**Site Photograph 5**

Seating area with  
timber planters.

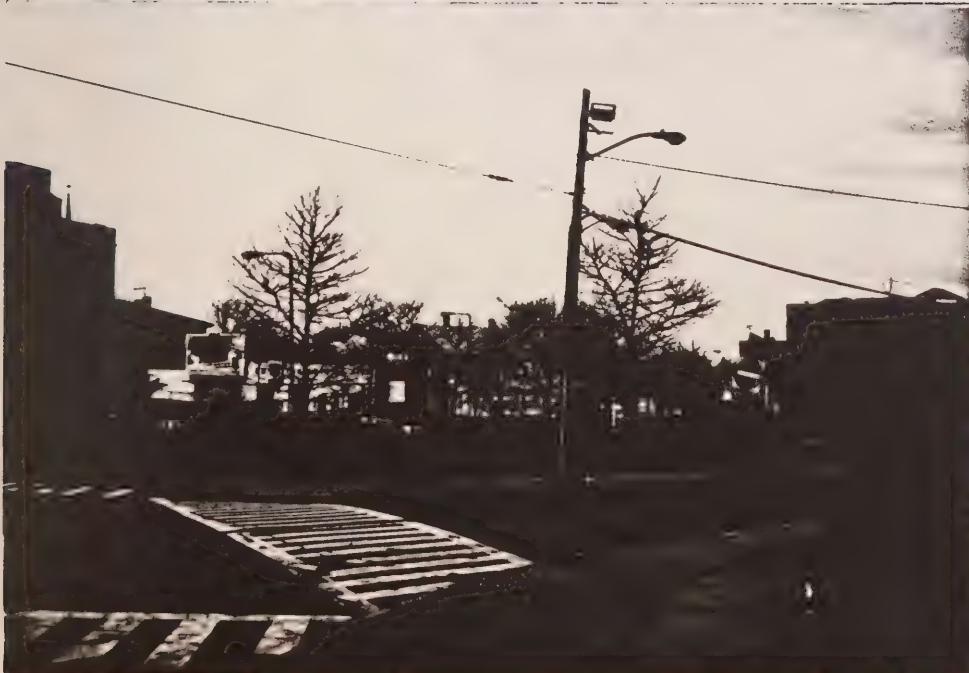
**Site Photograph 6**

View from courthouse.

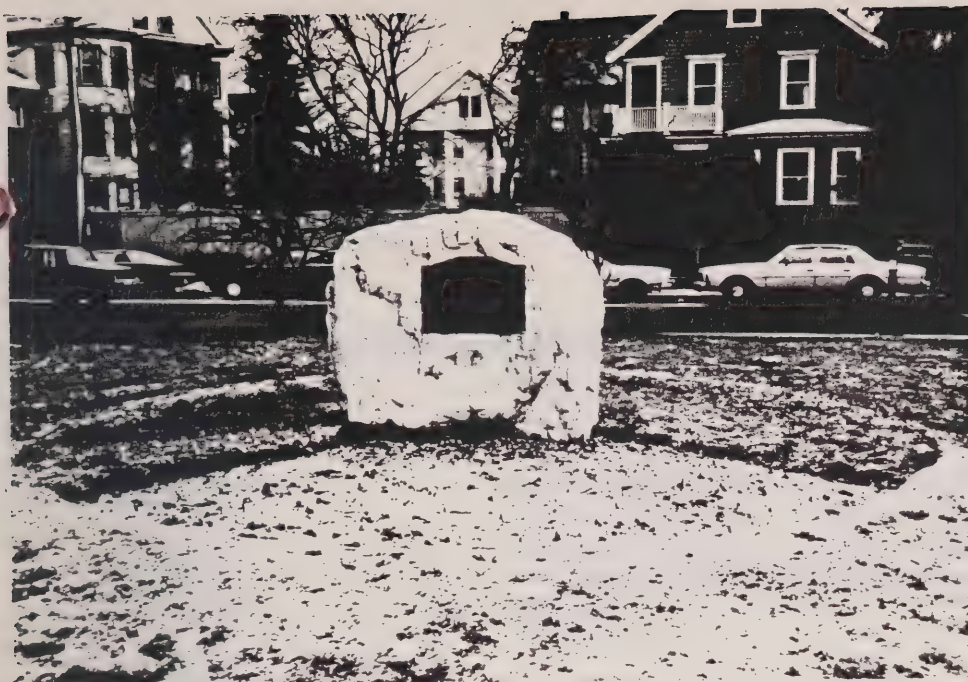
### **Site Photograph 1**

Memorial showing  
flower bed, granite  
curbing.

The few standard park-built elements, curbs and the monument, are in good condition.

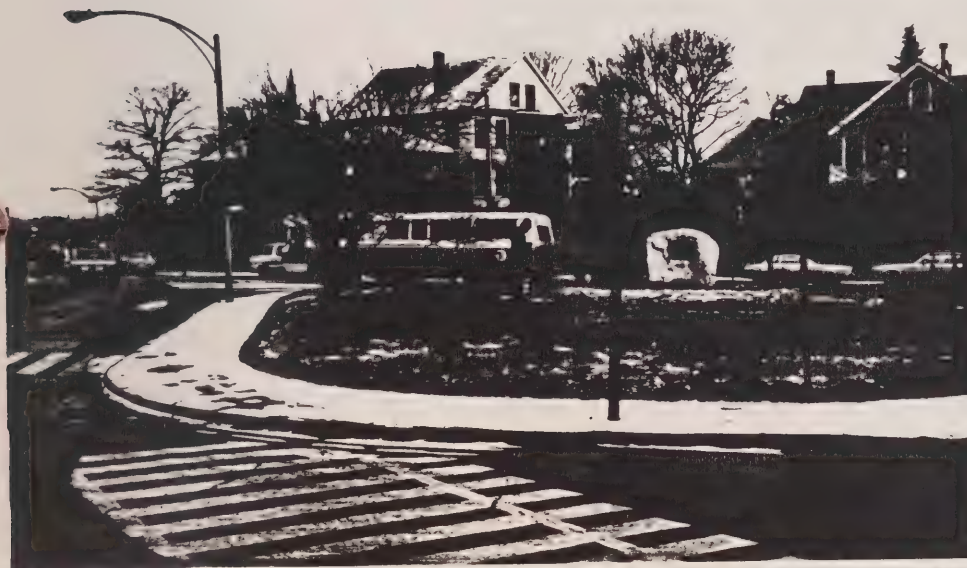
### **Site Photograph 2**

View at corner of  
Chestnut Hill and  
Winship.

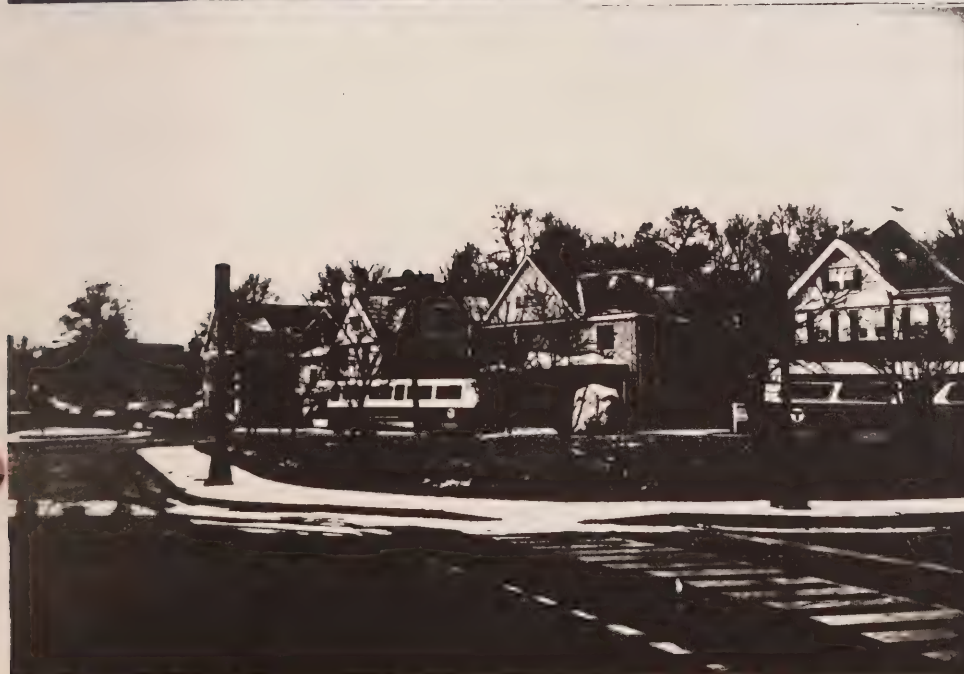
### **Site Photograph 3**

View from Winship  
Street.

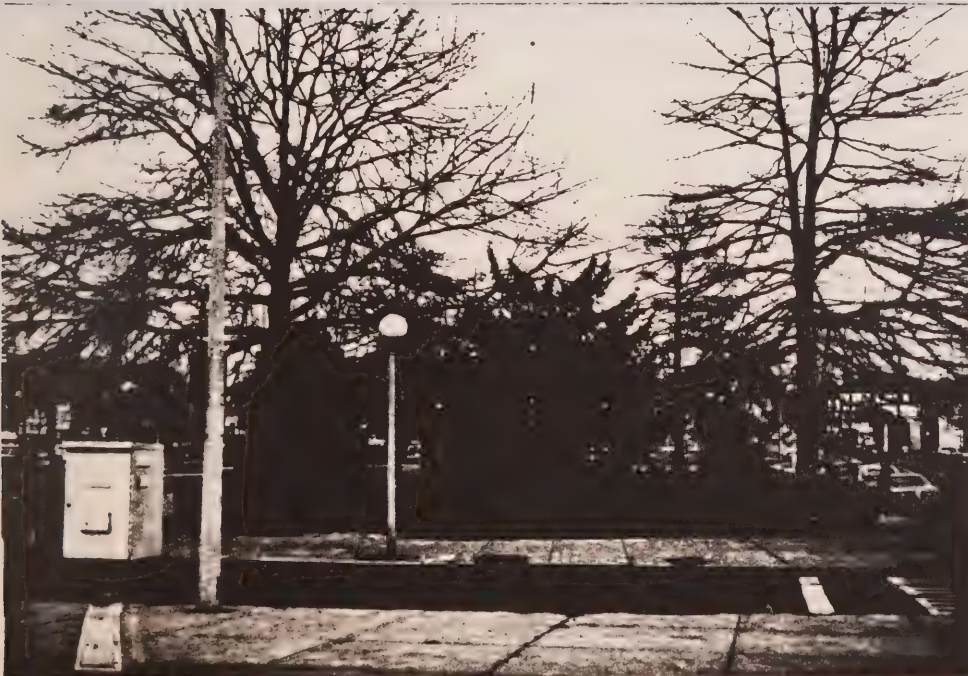
**Site Photograph 3**

Shows park in its context. A visual "green oasis". Fence protects park from overuse, cutting through.

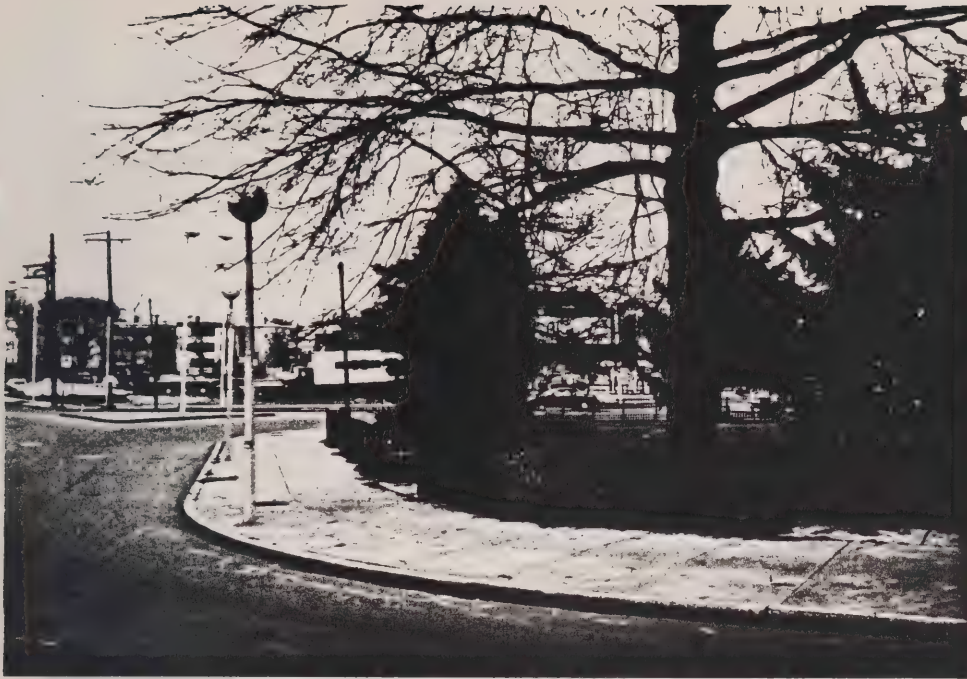
**Site Photograph 4**

Opportunities for  
additional benches.  
Trees limbed up.

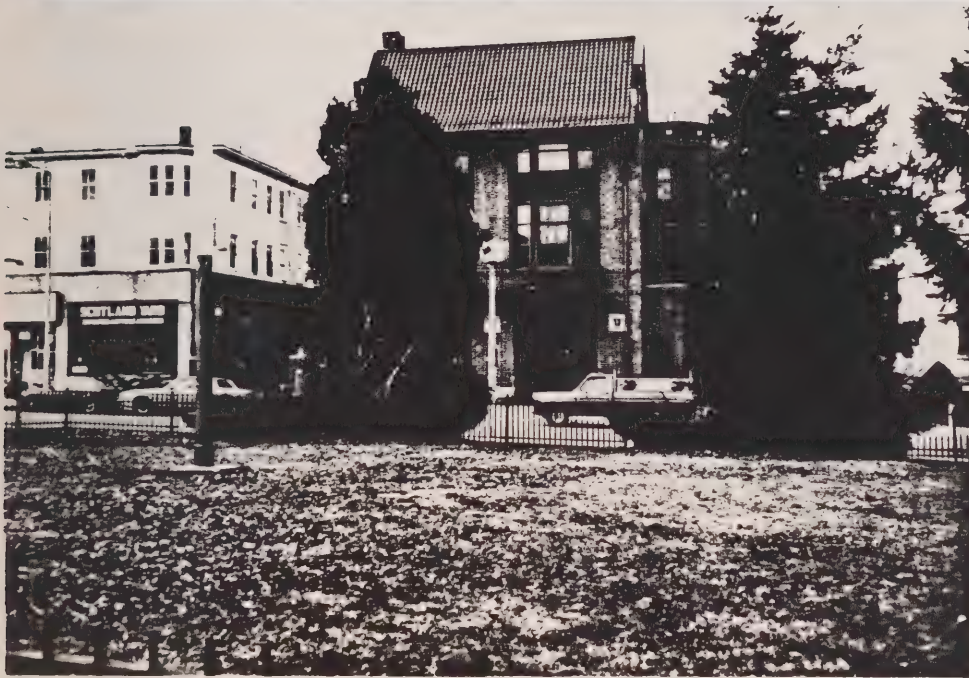
**Site Photograph 5**

View across park.  
Weed species need to  
be removed.

The plantings are in fairly good condition, yet need maintenance.

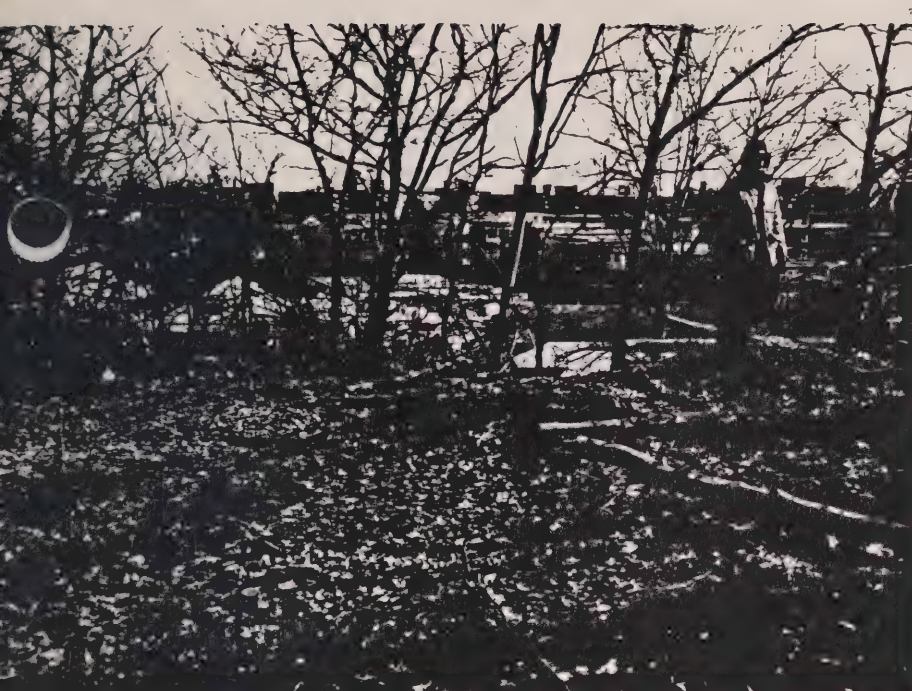
**Site Photograph 1**

View from top of site.  
Trees have been  
recently cut down.  
Seems to have been  
unauthorized.

Unauthorized cutting of trees

selective thinning at base

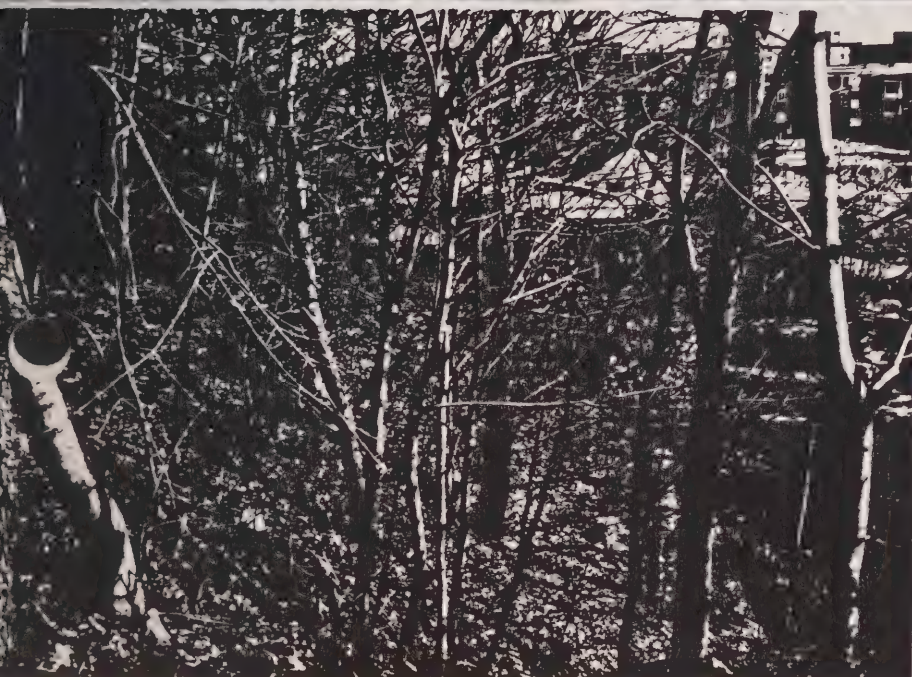
**Site Photograph 2**

Typical view through  
site. Shows steepness  
of slope.

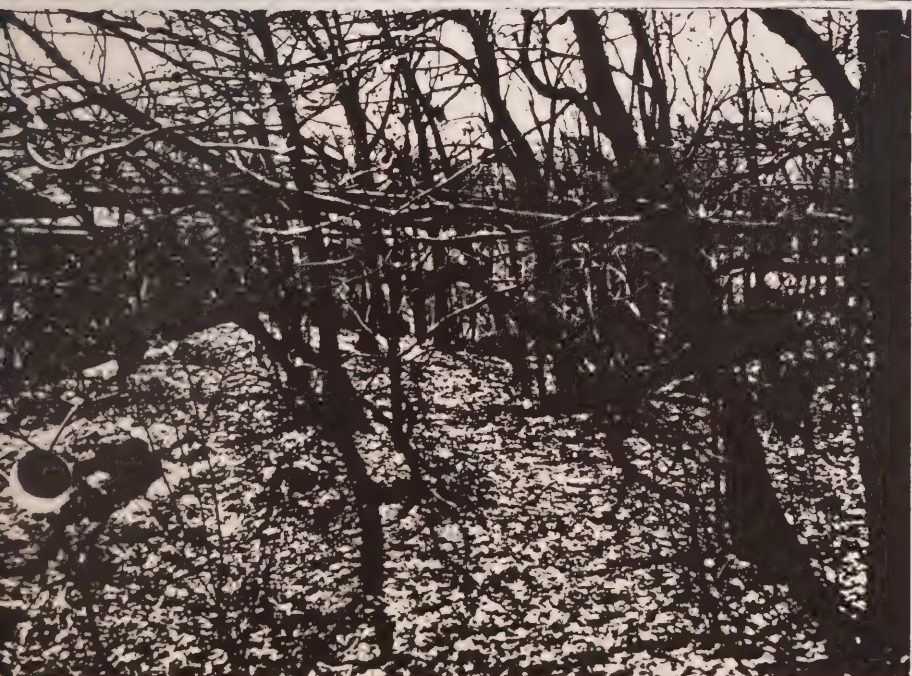
**Site Photograph 3**

Crest of site showing  
rock outcroppings.
